HEADQUARTERS 540TH ENGINEER REGIMENT A.P.O.#464

Subject: 5-2 Journal for Month of November 1943.

RESTRICTED APPENDIX A ENGINEER ROAD AND BRIDGE RECONNAISSANCE NO.10-1 ROAD OVERLAY NOTE REFER TO FOLLOWING SHEETS FOR DESCRIPTION OF SITES INDICATED BY NUMERALS.

<u>R E S T R I C T E D</u> Engineer Road and <u>Bridge</u> Reconneissence No.10-1.

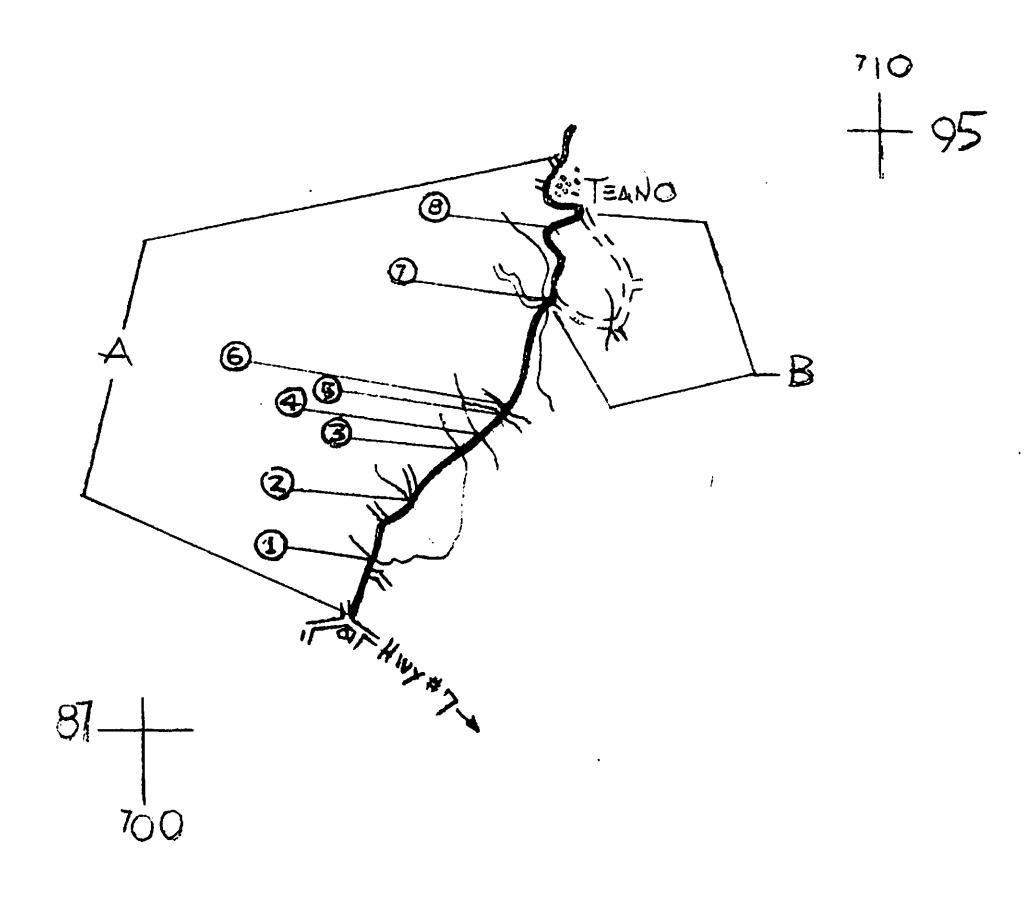
- A Road "A" from junction with Highway 37 for four point five (4.5) miles, to TEANO, is a two way (eighteen (18) feet wide), crushed rock road, with a generally smooth surface, gentle grades, and gradual curves.
- B Road "B", an alternate route to T"AND from its intersection with Road "A" at NO54928, for one point six (1.6) miles, is a two way, crushed rock road, with generally smooth surface, gentle grades, and gradual curves.
- (1) <u>Description</u> Demolished mesonry bridge replaced by Bailey.

NOTE #1 - Suggest that north bound traffic for TEANO be routed over Highway #6 and secondary road from junction with #6 at NOSE911 to TEANO, during period of bridge construction on Road "A" permitting siting of fixed bridges on original abutments.
