BUILDING THE LIBBY BRIDGE

**84TH ENGINEERS
KOREAN WAR**

By Charles Hendricks
USACE Office of History

Extracted from the Aug, 1989 USACE Pamphlet, EP 870-1-32
Title: Bridging the Imjin: Construction of Libby and Teal Bridges
During the Korean War (October 1952 - July 1953)

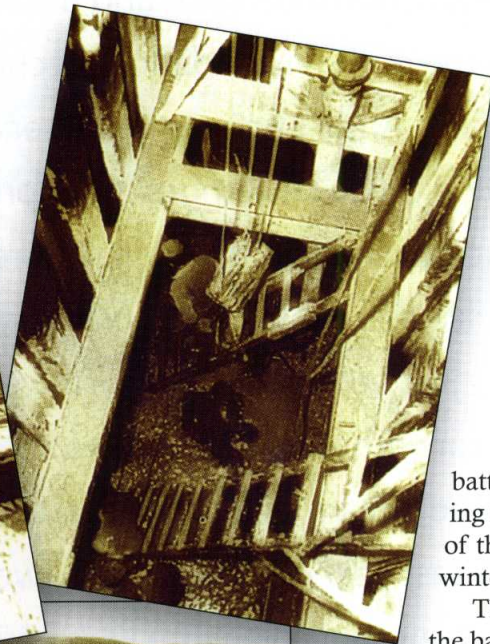
Clockwise, starting at top left: Pile driving at cofferdam #1 in February, 1953. The pier bases were constructed by driving grooved sheet piles to form a rectangular caisson which was then excavated to bedrock and filled with concrete. Interior view of a cofferdam showing 12-inch I-beams that helped absorb outside pressure. Cofferdam #3 has received 240 cubic yards of concrete as the initial pour ("A") and is being cured with water.

The pier bases were constructed by driving grooved sheet piles to form a rectangular caisson which was then excavated to bedrock and filled with concrete. The tolerance allowed in rolling the sheet piling in Japan was too great; in some cases it varied as much as three-quarters of an inch in width. Some of the piles were painted with red lead and some were not. The tolerance was less on the painted piles, and most of the splits in the piling were found at junctures of the two types. Also the corner piles had ball-and-socket joints, while the side piles had thumb-and-finger joints; this again made it very difficult to fit properly. The tolerance in the grooves caused leaks all up and down the joint. Lead wool was used to pack the joints, but this did not stop the water. Eventually soft wooden wedges, driven into the joints, proved to be a fairly effective means of stopping the flow.

The poor quality of the sheet piling greatly increased the difficulties of de-watering the cofferdams to permit excavation down to bedrock. In addition, the rough, irregular surfaces of the bedrock made it almost impossible to get a tight seal between pile and rock. Blowouts under the piles inevitably occurred before the final clean-up could be completed. Frequently the sheet piles split near the bottom, with the result that backfill (filling up the excavation), pile extraction, and re-drives were necessary... as many as three times for one of the cofferdams. Unfortunately, when cofferdam 6 was excavated, the pile extractor had not arrived yet, and it was necessary to make the initial concrete pour completely under water. On the other cofferdams, as excavation proceeded, it was possible to remove boulders that obstructed full pile penetration, extract and replace bent piles, and then drive the piles all the way to bedrock. In excavating cofferdam 1, it was found that the piles at one corner had struck a layer of basalt; however, it was possible to backfill, extract the bent piles, replace them, and drive on down to bedrock.
